HYDRAULIC MODEL INVESTIGATION LIBBY DAM KOOTENAI RIVER
MONTANA HYDRAULIC... (U) ARMY ENGINEER DIV NORTH PACIFIC
BONNEVILLE OR DIV HYDRAULIC L... L Z PERKINS ET AL.

4. TITLE (and Subtitle) LIBBY DAM, KOOTENAI RIVER, MONTANA Hydraulic Model Investigations		5. TYPE OF REPORT & PERIOD COVERED
7. AUTHOR(s)		6. PERFORMING ORG. REPORT NUMBER

LIBBY DAM, KOOTENAI RIVER, MONTANA
Hydraulic Model Investigations
PART I: INTRODUCTION

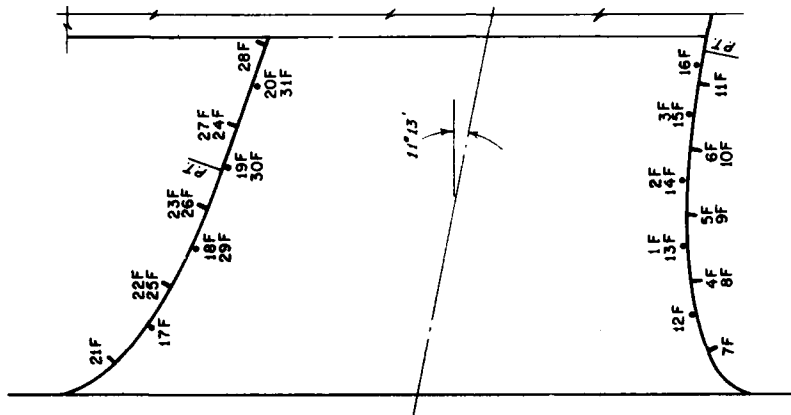
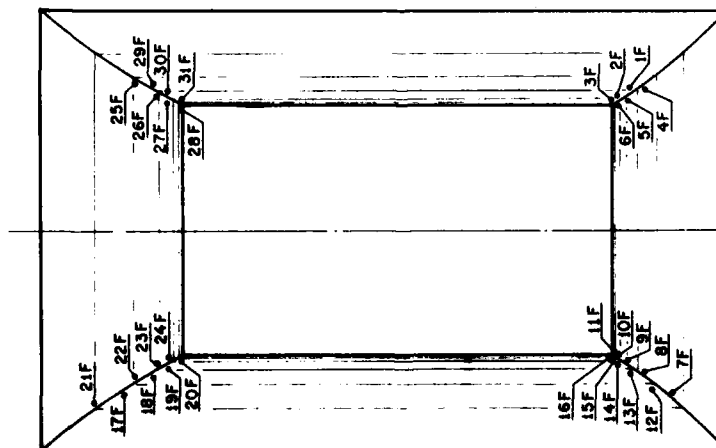
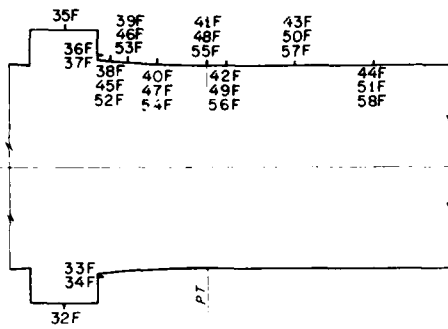
NOTE
ENTRANCE DETAILS SHOWN ON PLATE 37.

FACE VIEW NORMAL TO CENTER LINE

SECTION ALONG CENTER LINE

PIEZOMETER LOCATIONS
PLAN F RIGHT SLUICE ENTRANCE

PLAN

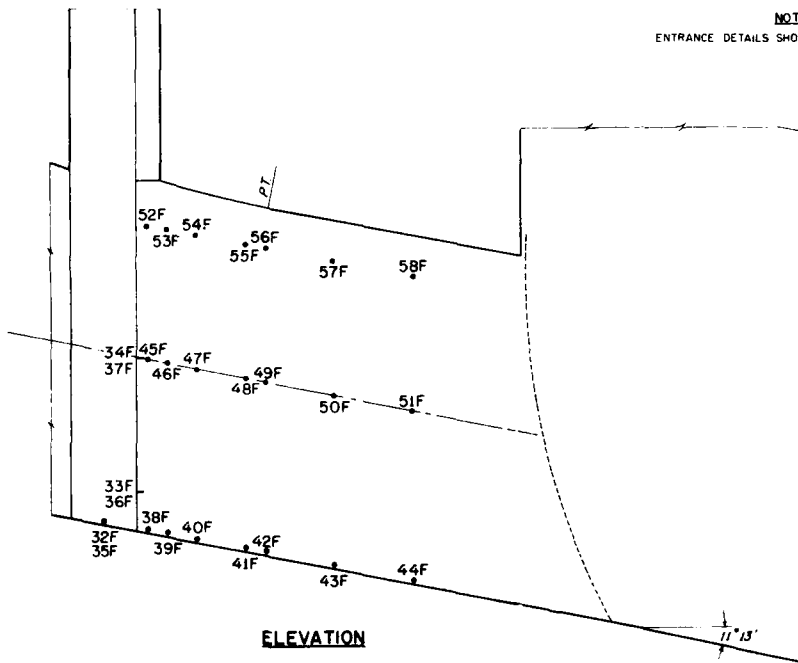
ENTRANCE DETAILS SHOWN ON PLATE 37

ELEVATION

PIEZOMETER LOCATIONS
PLAN F BELLMOUTH TO VALVE

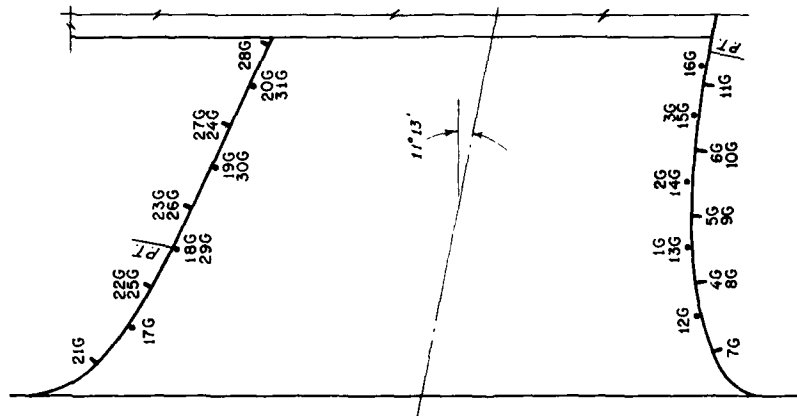
NOTE
ENTRANCE DETAILS SHOWN ON PLATE 40.

FACE VIEW NORMAL TO CENTER LINE

PIEZOMETER LOCATIONS
PLAN G RIGHT SLUICE ENTRANCE

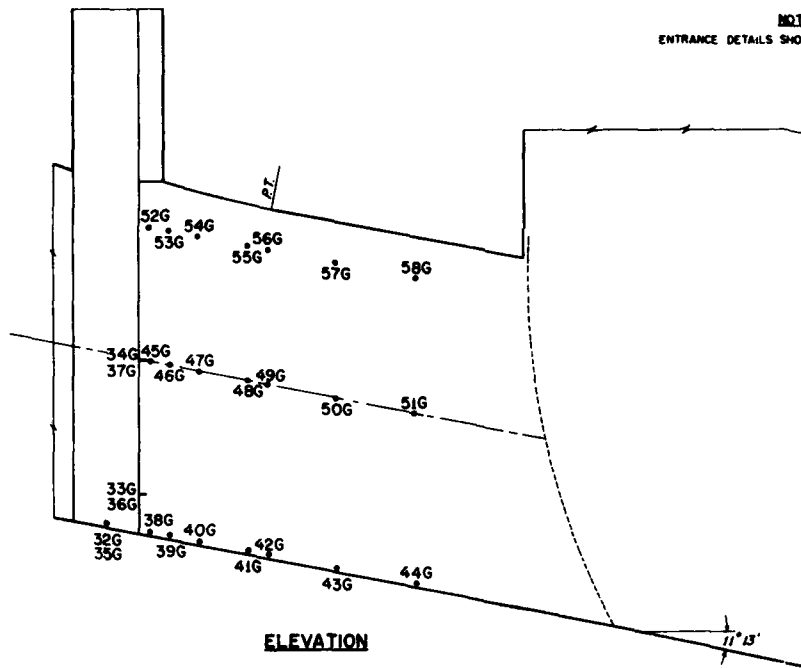
NOTE
ENTRANCE DETAILS SHOWN ON PLATE 40.

**PIEZOMETER LOCATIONS
PLAN G BELLMOUTH TO VALVE**

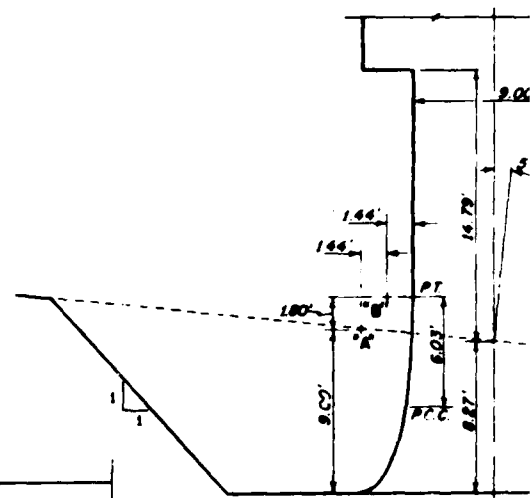
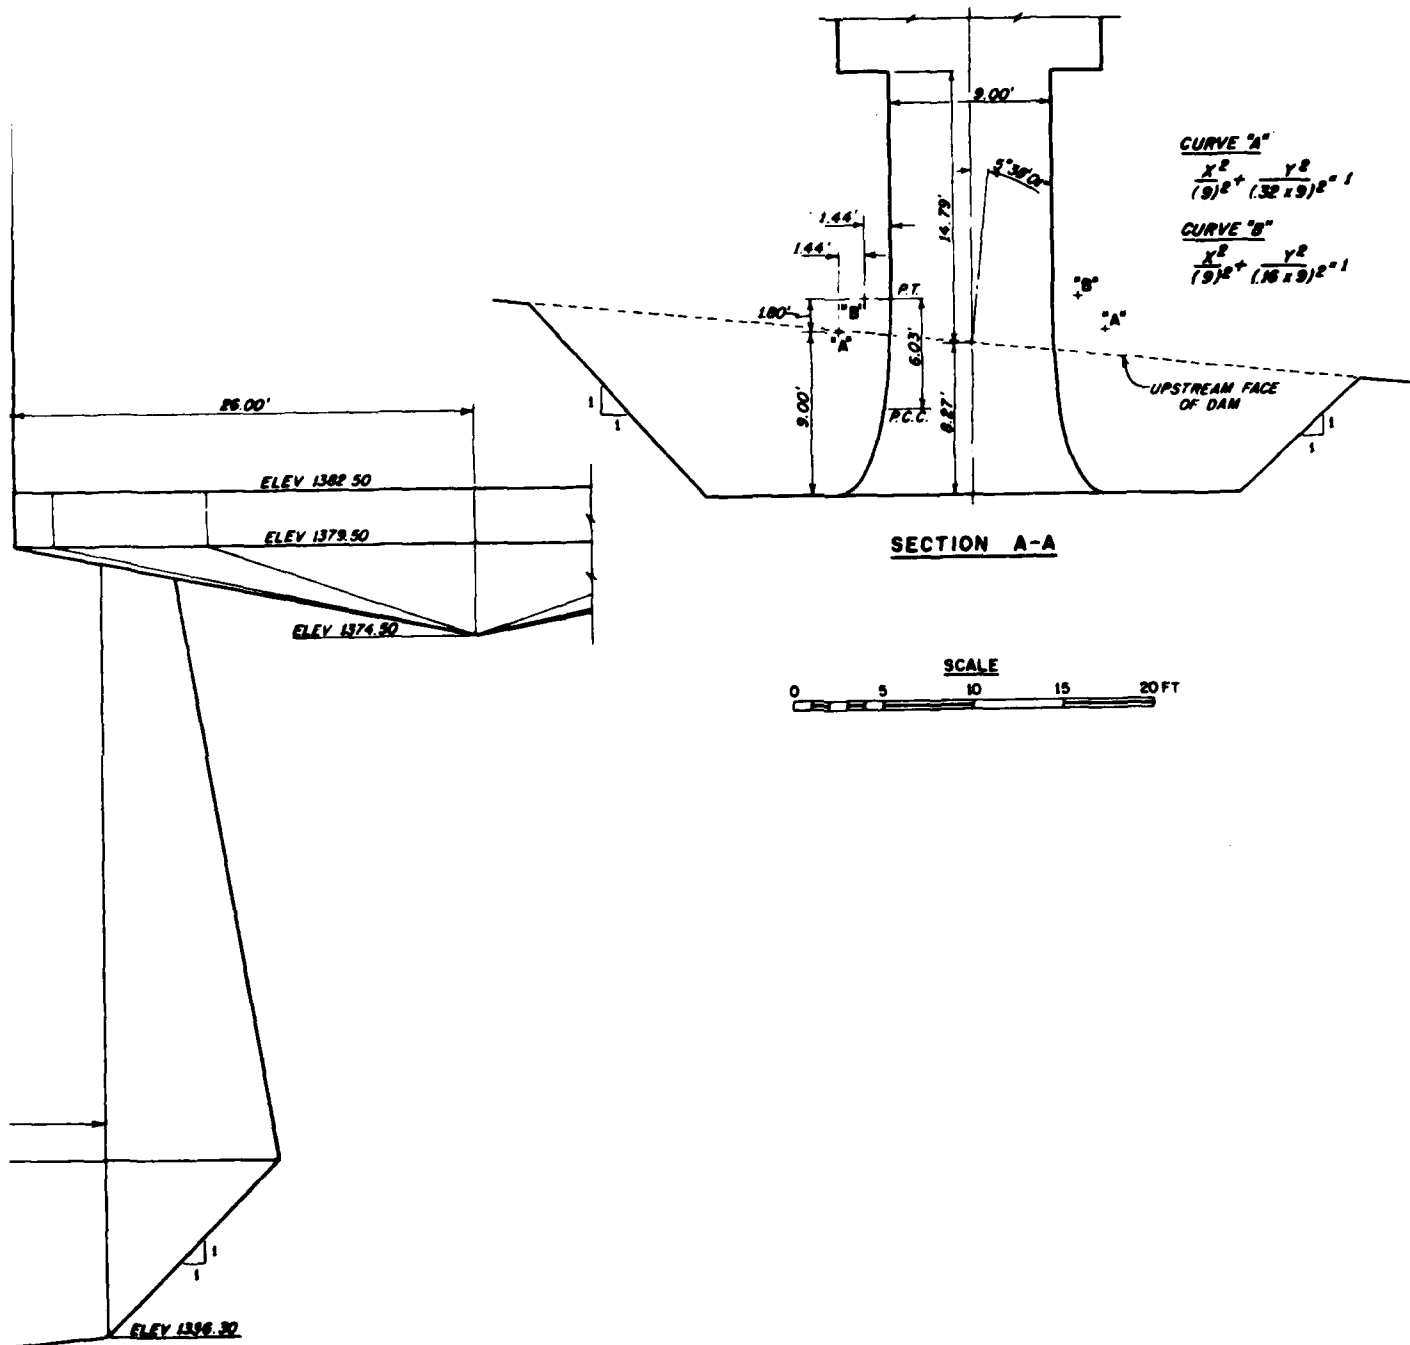
FACE VIEW OF INTAKE

SECTION

DWORSHAK DAM
PLAN D RIGHT CONDUIT ENTRANCE

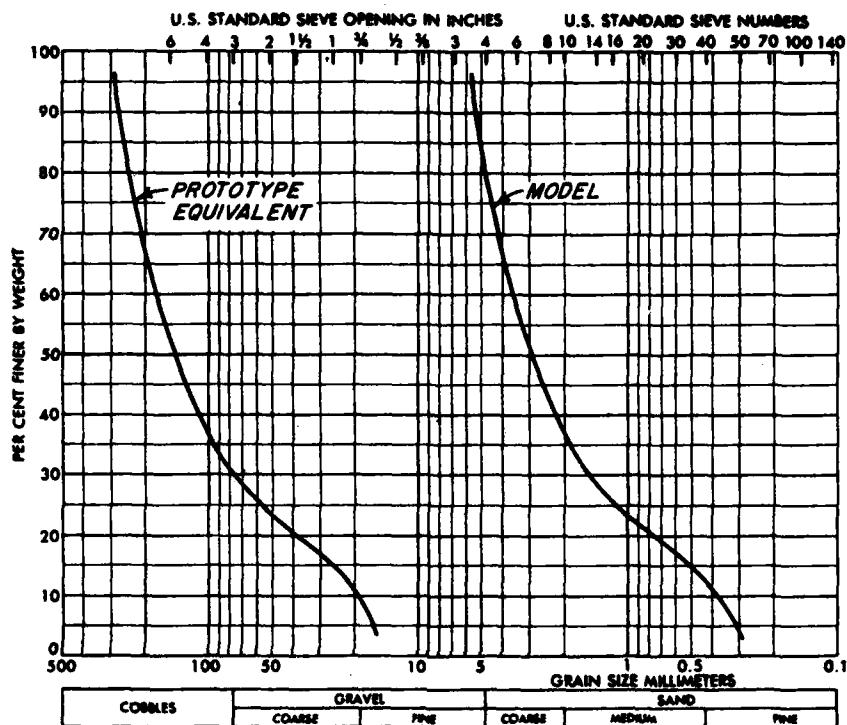
GRAIN-SIZE DISTRIBUTION
MOVABLE BED TEST

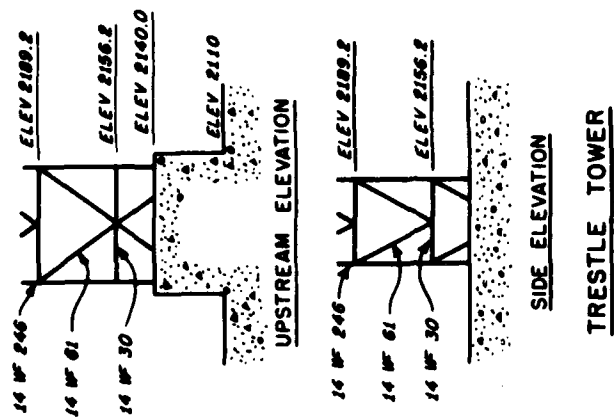
LOW MONOLITHS 33 TO 35
AND
TEMPORARY TRESTLE TOWER

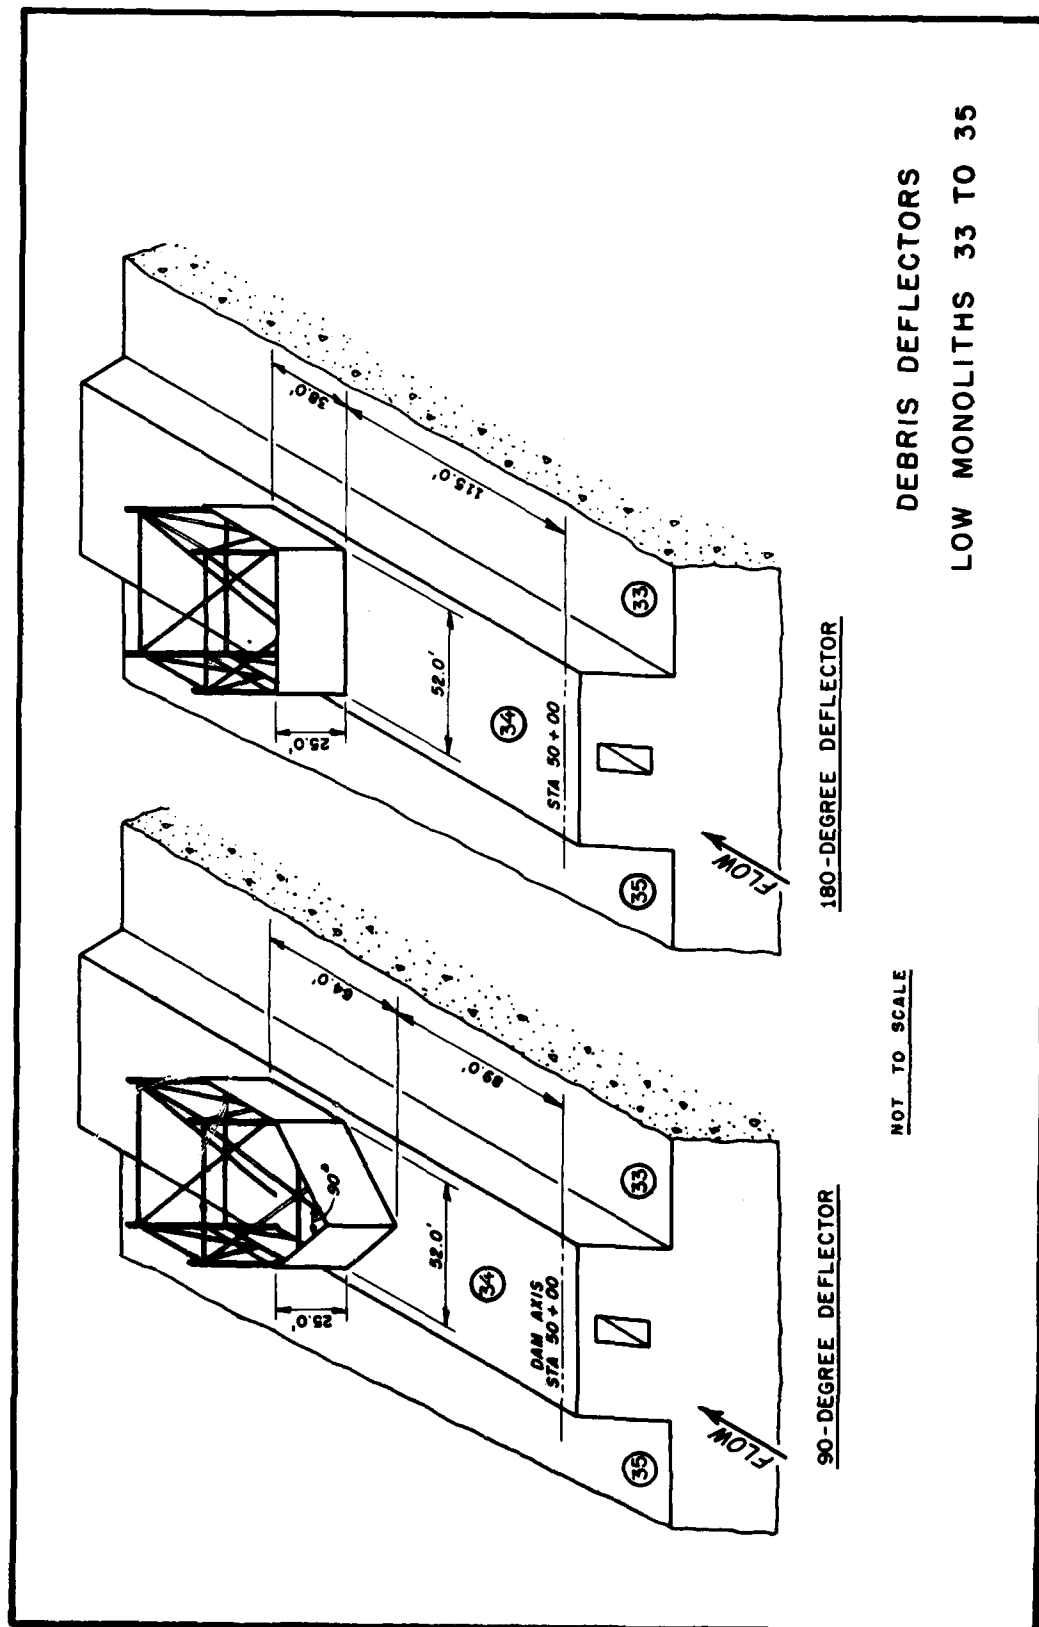
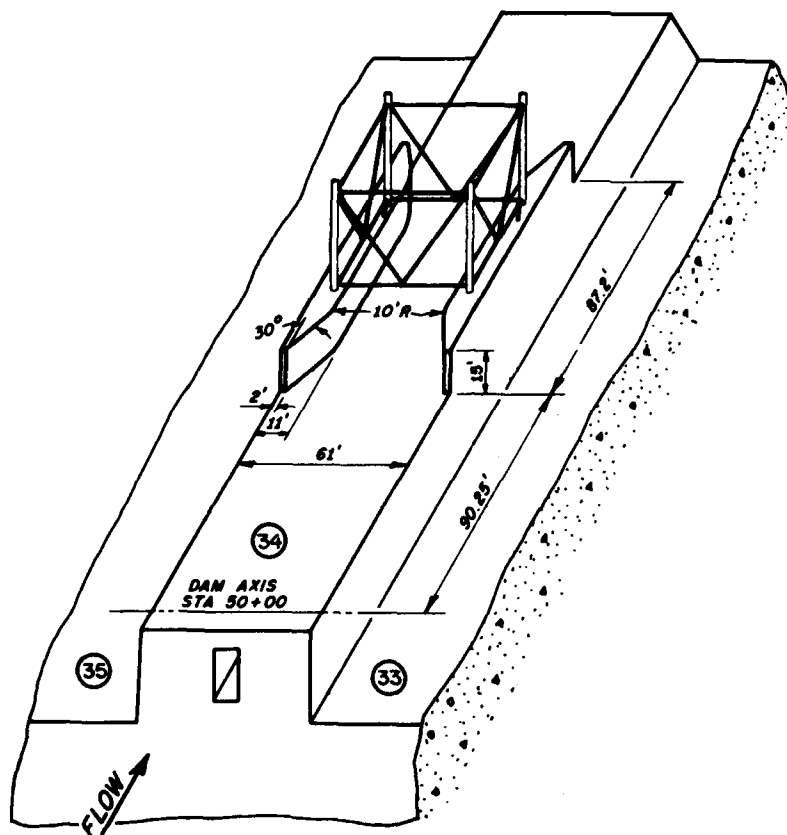
CONTRACTOR'S DEBRIS DEFLECTOR

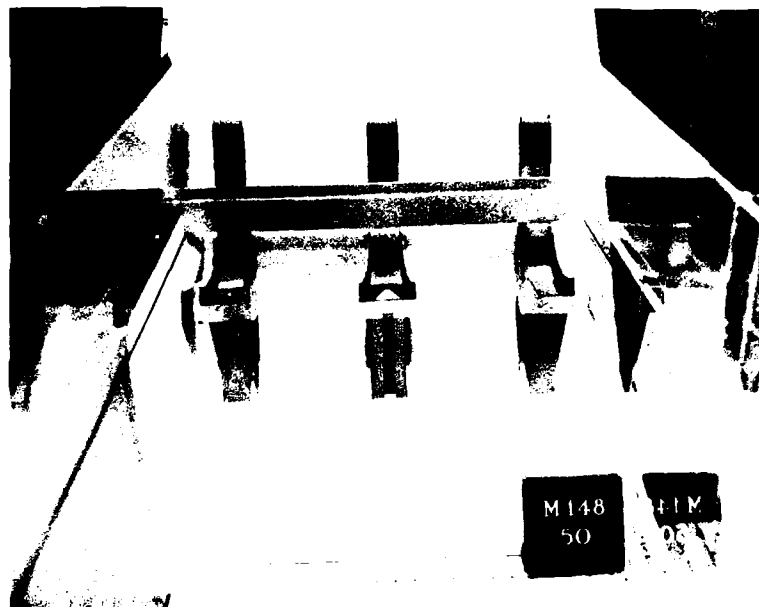
View from downstream

Side view

Photograph A-4. Plan E, 30-degree flip bucket at sluice outlets.

5. Flip buckets that would project the sluice flow over the stilling basin into relatively shallow water on the runout slope and reduce the amount of nitrogen that would be absorbed were tested (photograph A-4). With normal pool elevation 2459 and a 30-degree flip bucket with lip at elevation 2127.7, zones of impact were on the stilling basin runout slope (photographs A-5 to A-7). With minimum pool elevation 2287, impact was in the basin and entrained air was carried to the basin floor at the end sill. After several combinations of deflectors and flip buckets were tested, flip buckets were abandoned because potential damage to the runout slope and waves in the exit channel were considered to be too severe.
